## **Monitoring Report No. 78**

**William Street  
Loughadian  
Poyntzpass  
Co. Down**

**AE/06/158**

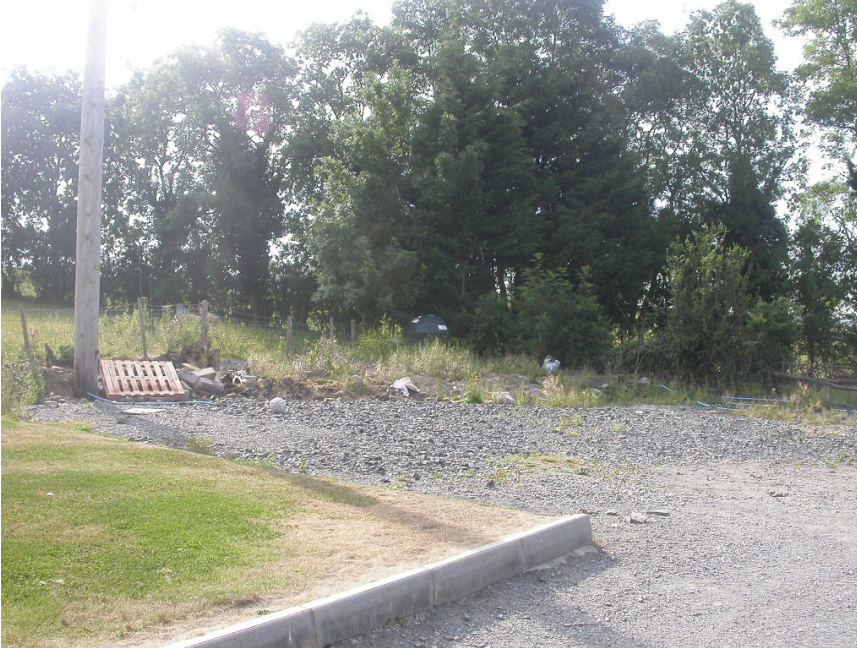
A planning application was made for the construction of a domestic garage at 9 William Street, Loughadian, Poyntzpass, Co. Down (Fig. 1 and 2). The proposed development site (Fig. 3, Plate 1) is located approximately 75m east of the site of a 12<sup>th</sup> Century castle (DOW:033:034) (Fig. 4), as indicated on the Sites and Monuments Record map. The site on which the garage is proposed to be built was extensively disturbed during construction of the dwelling house in 1998. Planning permission had been granted for the garage at this time but this permission elapsed and the garage was never constructed (Rodney McCombe pers. comm.). As a result of a fresh planning application for the garage an archaeological evaluation was requested.

Plate 1: Overall view of site from north-west prior to excavation of evaluation trenches.

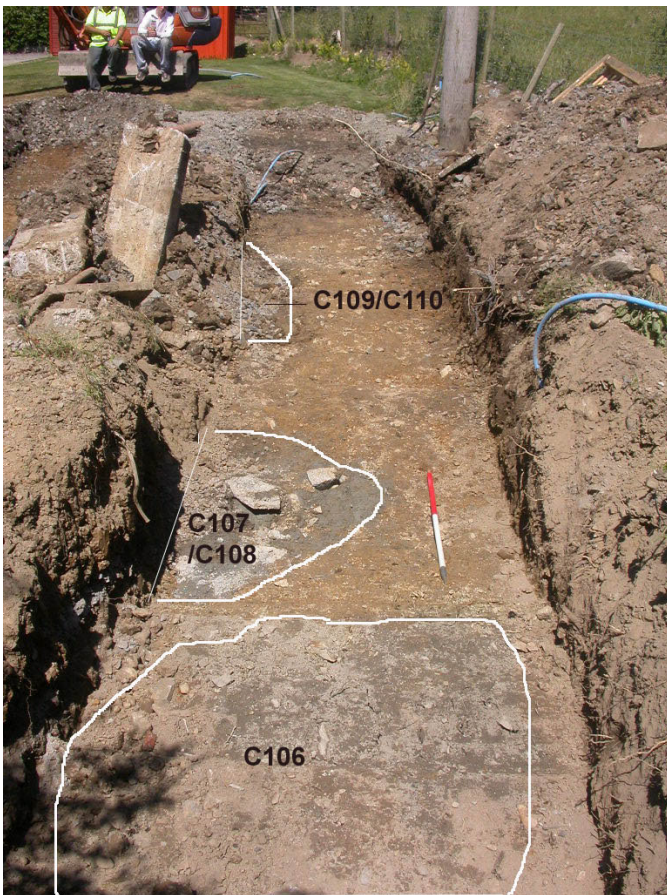
Trench A (Plate 2) measured approximately 12m by 1.65m. The requested length of Trench A was 15m but the northernmost 3m could not be excavated due to the presence of a water pipe and an oil pipe. As mentioned above, the site for the garage had been extensively disturbed during ground works associated with the construction of the dwelling in 1998. This disturbance involved the removal of some of the topsoil and the subsoil also appeared to be slightly truncated. Much of this material was then dumped on the southern part of the evaluation area. These works were presumably associated with the initial preparation of the ground for the construction of the garage. The exposed part of the evaluation area was then covered with a mixture of the disturbed topsoil and subsoil (C105) and then sealed with hardcore (C104). Presumably this area was levelled with the disturbed soil (C105) and hardcore (C104) when it was decided not to build the garage immediately. At the southern end of Trench A (Plate 3), the overburden (C101), which was a mixture of disturbed subsoil, topsoil and quarry dust had a depth of up to 0.70m. Underlying this was the original sod (C102) which was present between 0.70m and 0.94m below the surface. The original sod (C102) overlay the subsoil (C103), an orangey brown, mottled grey, silty clay with occasional stone inclusions. The interface between the original undisturbed ground and the disturbed layers was given the context number (C111). C111 represents the 1998 cut associated with the scarping of topsoil and subsoil.

Plate 2: View of Trench A from south, after excavation to surface of subsoil (C103).

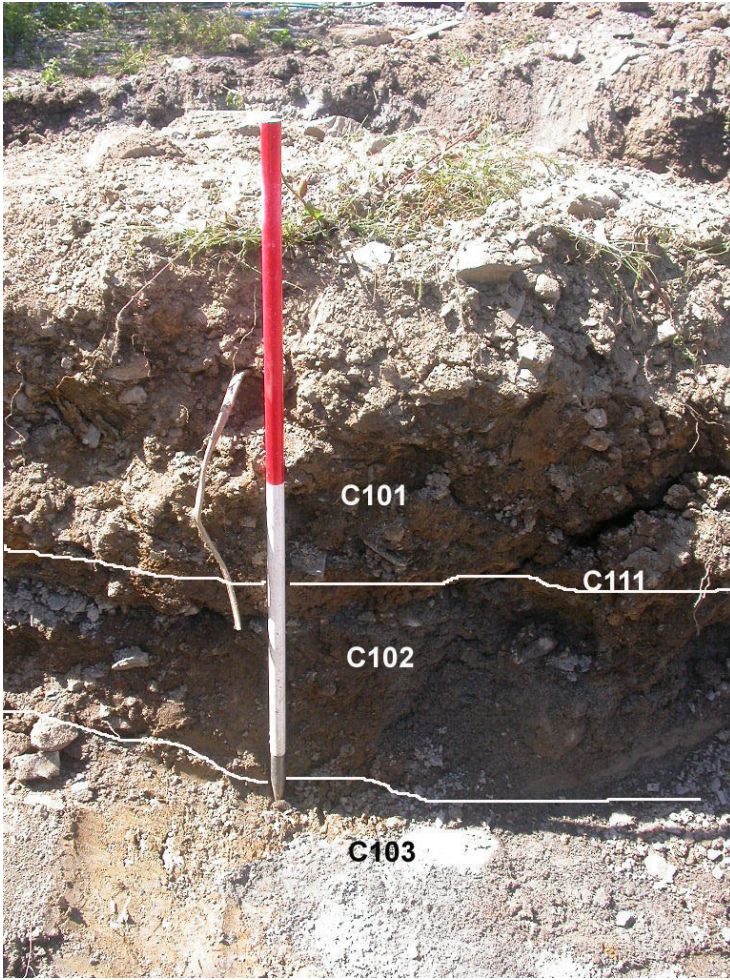
Plate 3: View of west-facing section in southern part of Trench A, after excavation to surface of subsoil (C103).

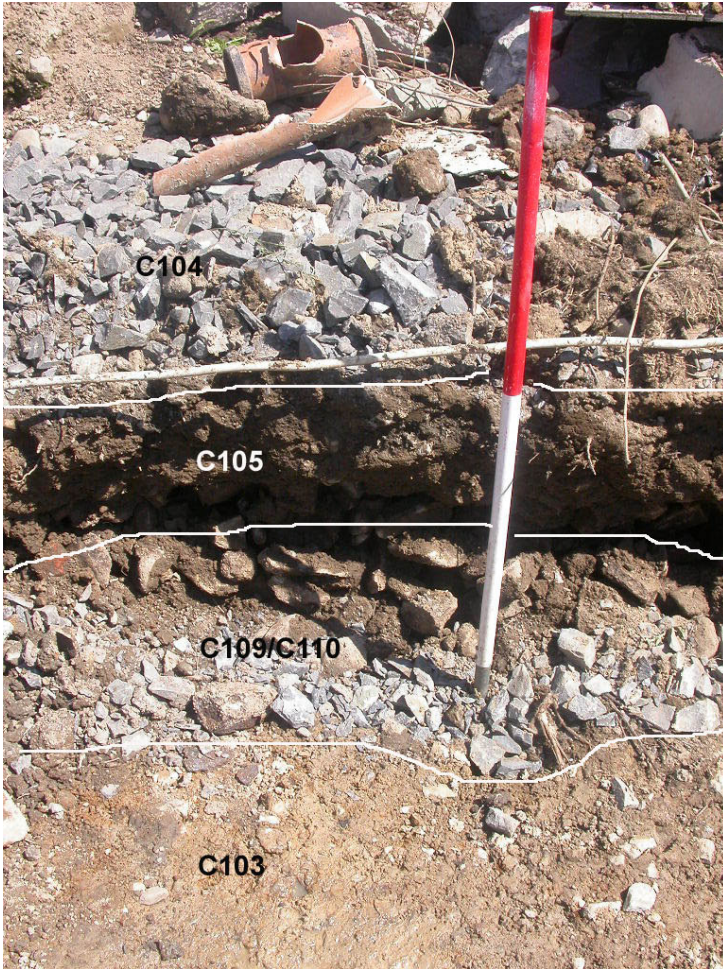
At the northern end of Trench A (Plate 4), the topsoil and subsoil had been scarped (C111) away and replaced with a layer of disturbed topsoil and subsoil (C105) which was sealed by a layer of hardcore (C104). The hardcore (C104) had a depth of up to 0.2m. The underlying disturbed layer (C105) was present between 0.2m and 0.65m below the surface. It overlay subsoil (C103), an orangey brown, mottled grey, silty clay. A modern, roughly circular spread of dark humic material with a strong oily smell (C106) was found at the southern end of Trench A. It measured approximately 2.4m in diameter and was very shallow, at up to 0.06m deep. Approximately 2.9m from the southern end of the trench was a modern cut (C107), which was

Plate 4: View of east-facing section in northern part of Trench A, after excavation to surface of subsoil (C103).

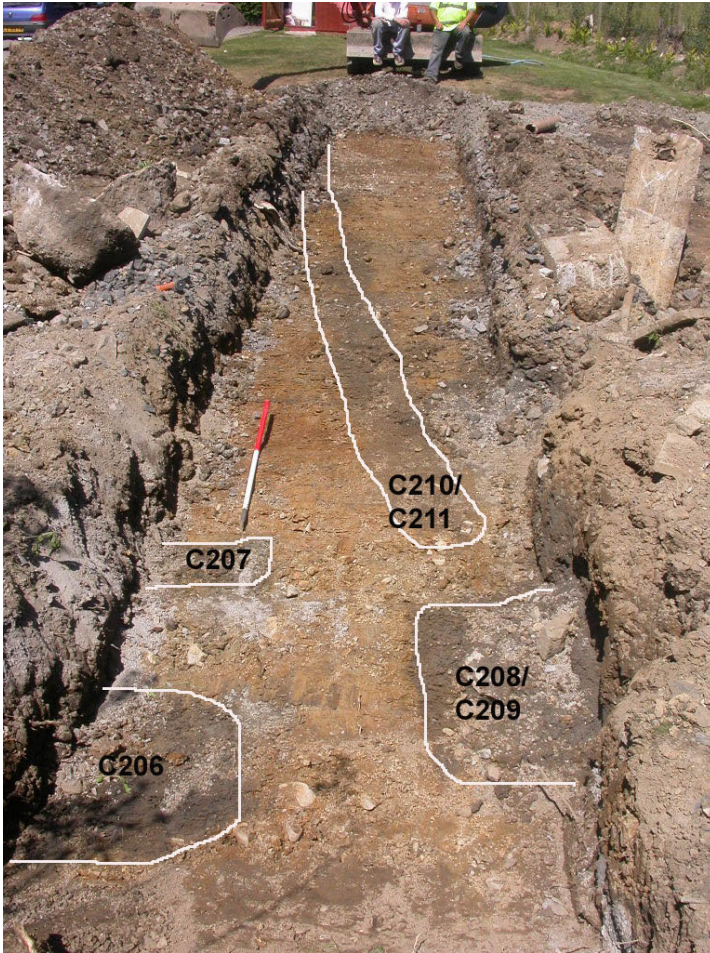
Trench B (Plate 5) measured approximately 13m by 1.65m. As in Trench A, there was a difference in stratigraphy between the northern and southern halves of the trench. At the southern end of the trench (Plate 6) there was a layer of overburden (C201) consisting of a mixture of topsoil and subsoil and quarry dust with a depth of up to 0.5m. Underlying this was the original sod layer (C202) which was present between 0.5m and 0.8m. This directly overlay the subsoil (C203), an orangey brown, mottled grey, silty clay. At the northern end of Trench B (Plate 7) a layer of hardcore (C204) sealed a disturbed layer of mixed topsoil and subsoil (C205). The hardcore (C204) was up to 0.5m deep and the disturbed layer (C205) was present between 0.5m and 0.8m below the surface. The subsoil (C203), an orangey brown, mottled grey, silty clay, lay directly underneath the disturbed layer (C205). The interface between the two halves of the trench is represented by the action of scarping (C212) of the topsoil and subsoil which was later spread across the site to level it.

Plate 5: View of Trench B from south, after excavation to surface of subsoil (C203).

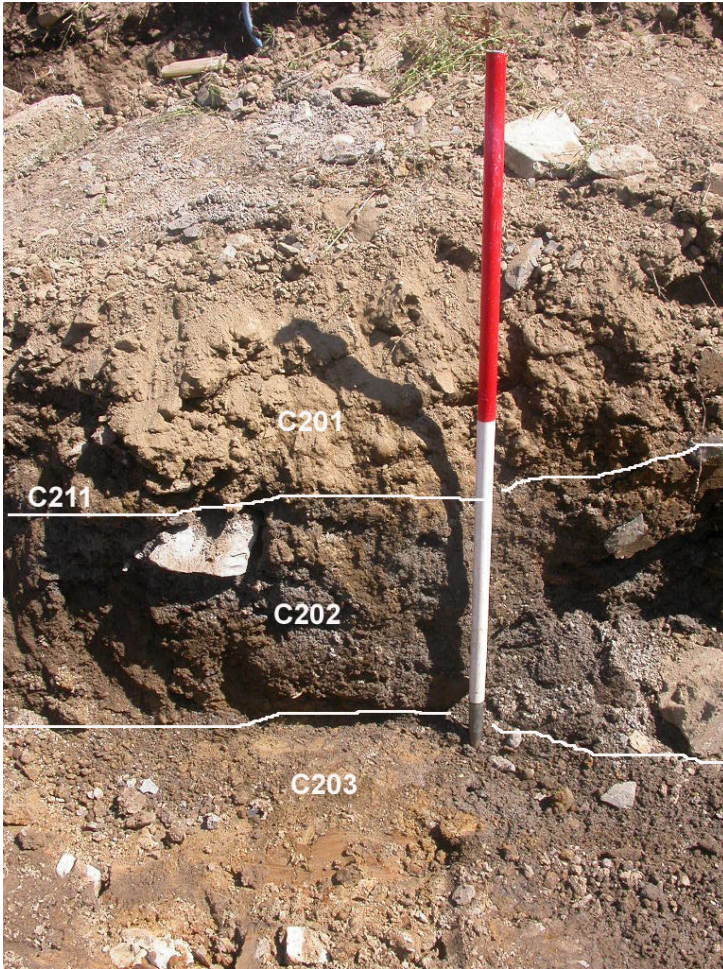
Plate 6: View of west-facing section at southern end of Trench B, after excavation to surface of subsoil (C203).

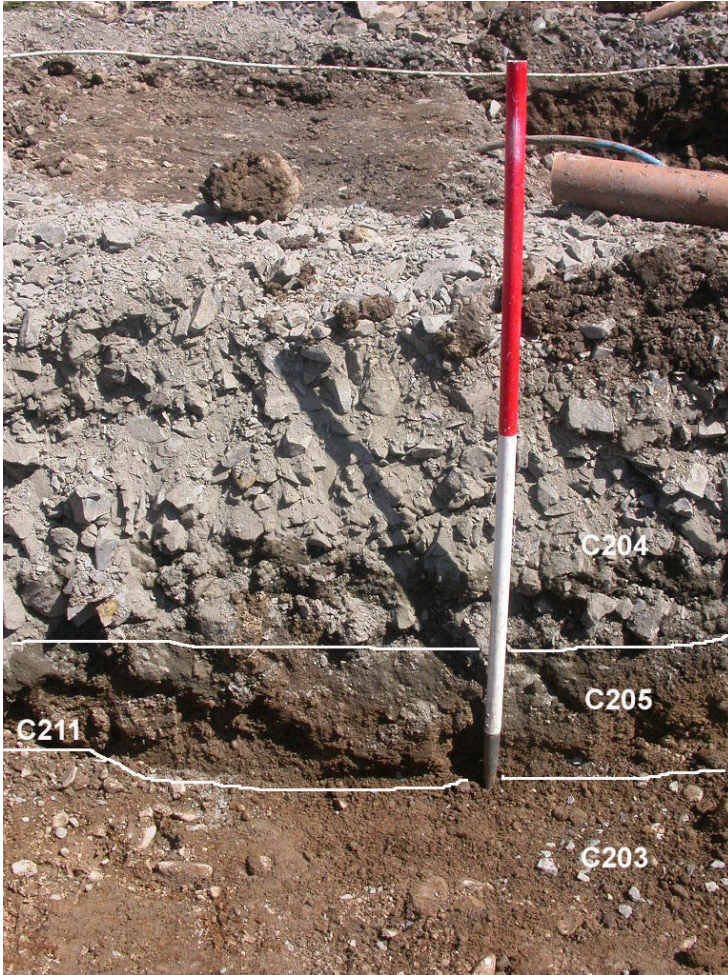
Plate 7: View of west-facing section at northern end of Trench B, after excavation to surface of subsoil (C203).
