## **Evaluation Report No. 143**

**50 Kirk Road  
Drummard (td.)  
Ballymoney  
Co Antrim**

**Licence No. AE/07/170**

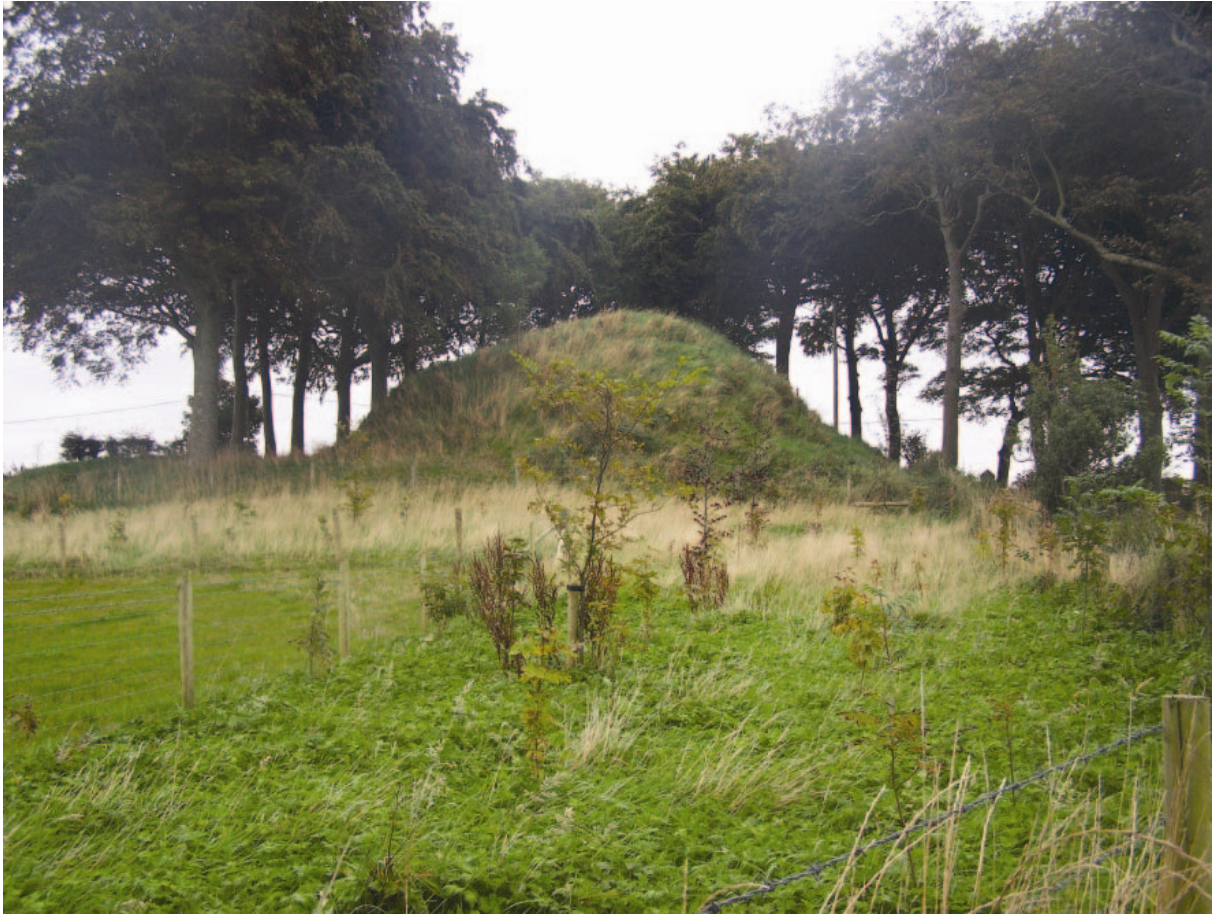
Plate 1: Motte (ANT 17: 005 S), looking SW. Note the trees along line of possible 18<sup>th</sup> century planting flanking the motte.

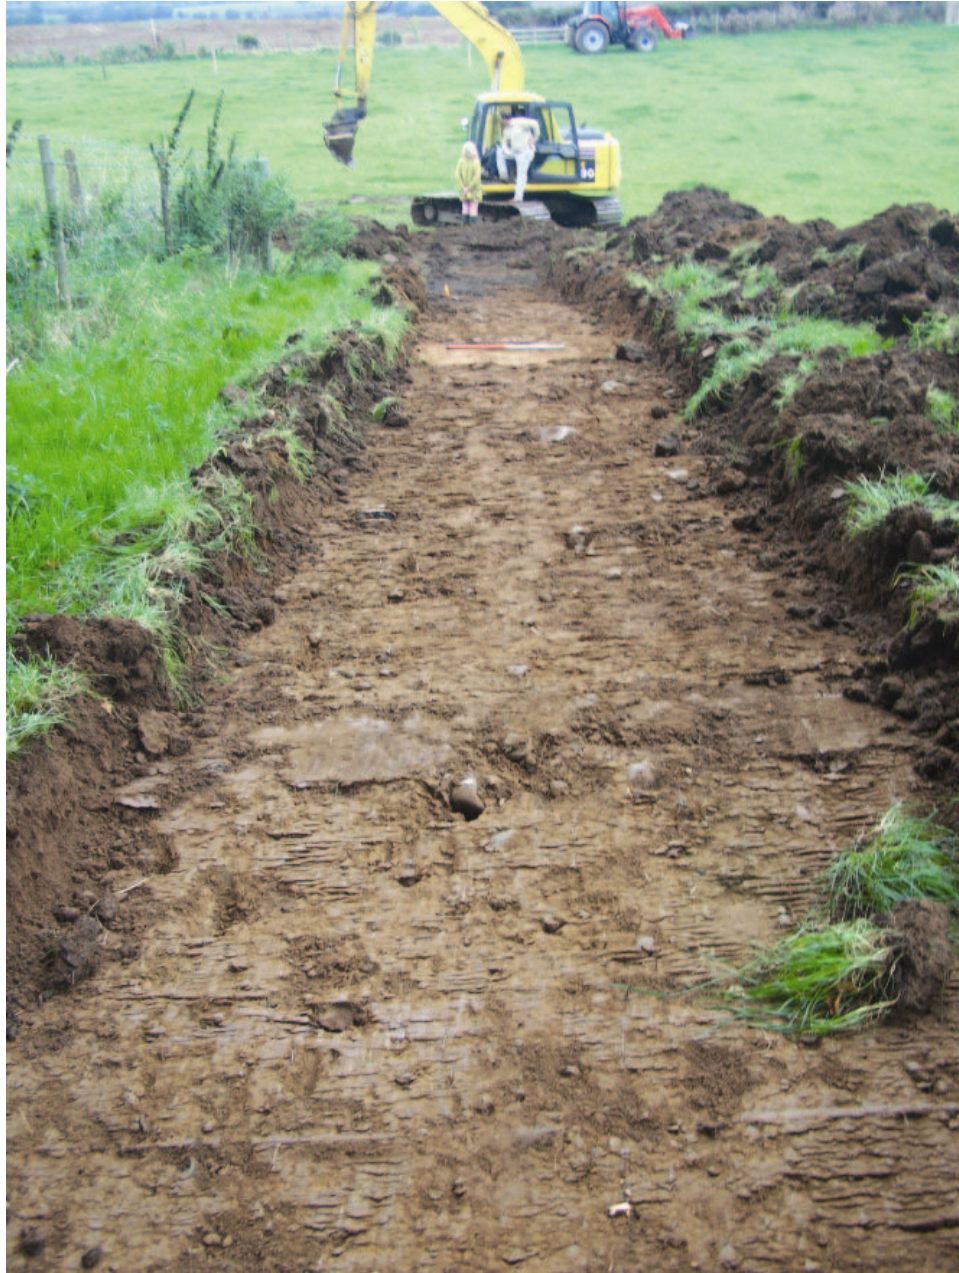
Plate 2: Excavation of Trench 1, looking NW. Note the exposed rectilinear band of sand (Context No. 104) with ranging rod laid horizontally. The grey ash layer (Context No. 108) is beginning to be exposed at the far end of the trench.

Approximately 25 metres from the SW end of Trench 1, a rectilinear band of grey sand extended across the trench with a tapered terminus, 80 cm maximum width, 75 cm maximum depth (see Fig 7; Plate 2, 3). The feature was archaeologically half sectioned, and the cut (Context No. 104) was noted as a steep sided 'stepped' post hole with a U shaped basal profile, widening towards the top of the feature (See Fig. 9; Plate 4 and 5). It was noted that the centre of the rectilinear feature was filled with a light grey sand (Context No. 106), surrounded by a light brown sand/clay (Context No. 105). With the excavation of Context No. 106 a dark line approximately 0.3 cm in depth was recorded (Context No. 107), which may indicate a relict land surface, and the possibility that the hill at this point had been artificially modified (see Fig 11).

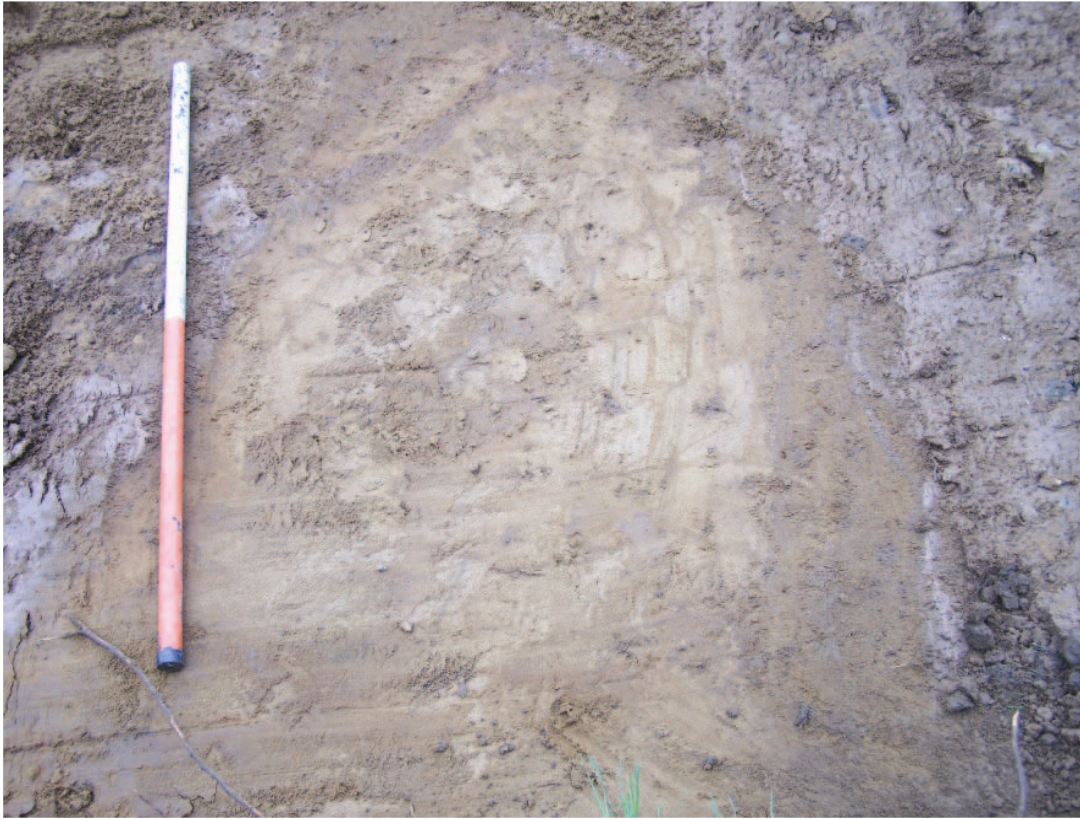
Plate 3: Trench 1 following exposure of grey sandy feature (Context No. 104), note the lighter sandy material (Context No. 106) at centre of the feature. Looking NE.

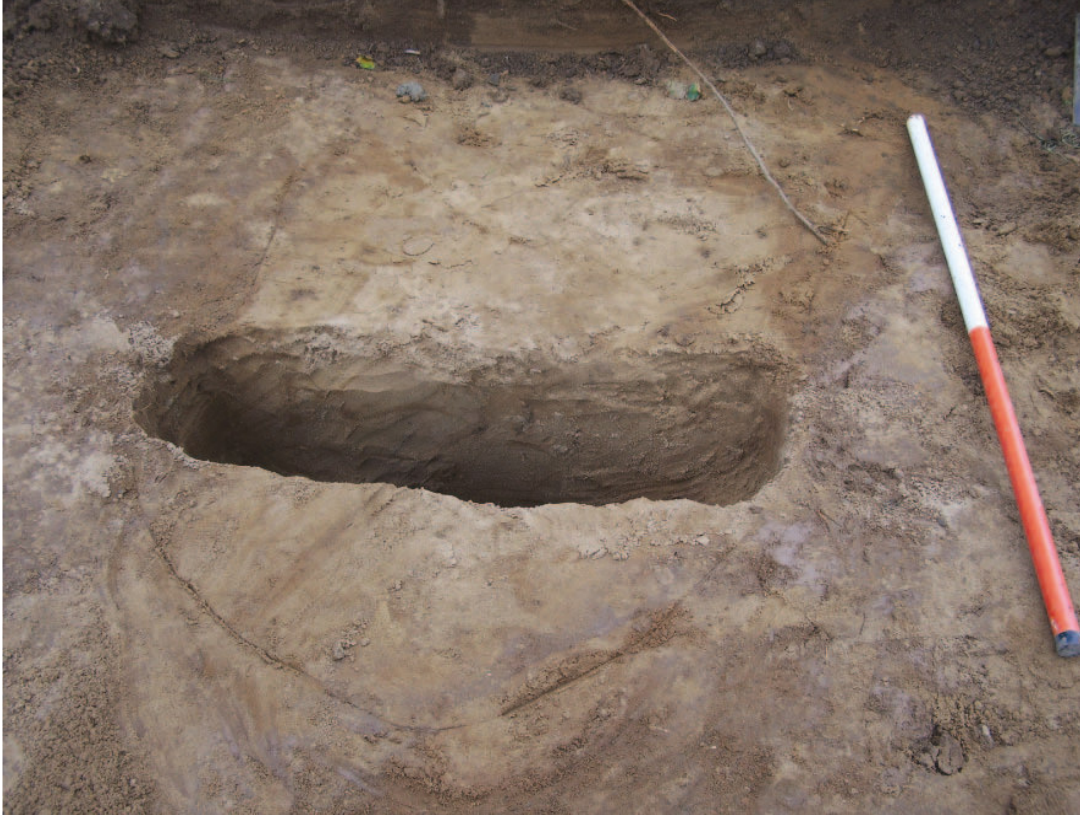
Plate 4: Feature 104 following half section, looking SW.

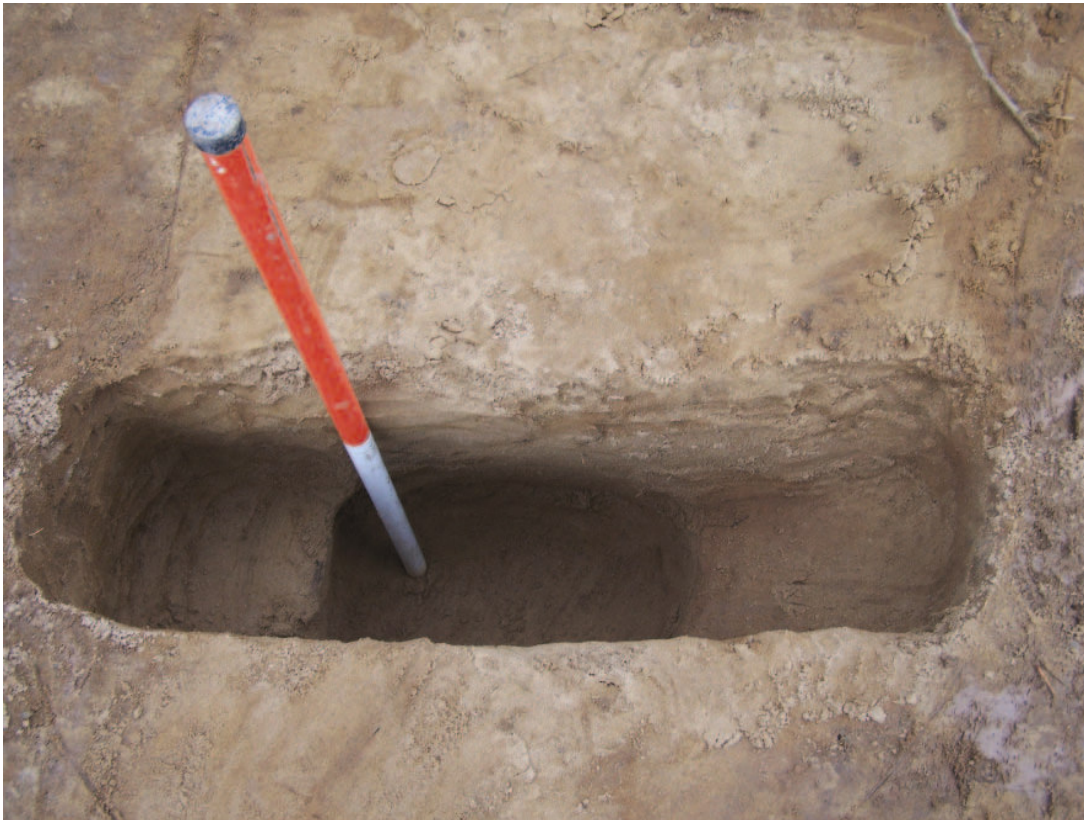
Plate 5: Feature 104 following half section, illustrating the stepped profile.

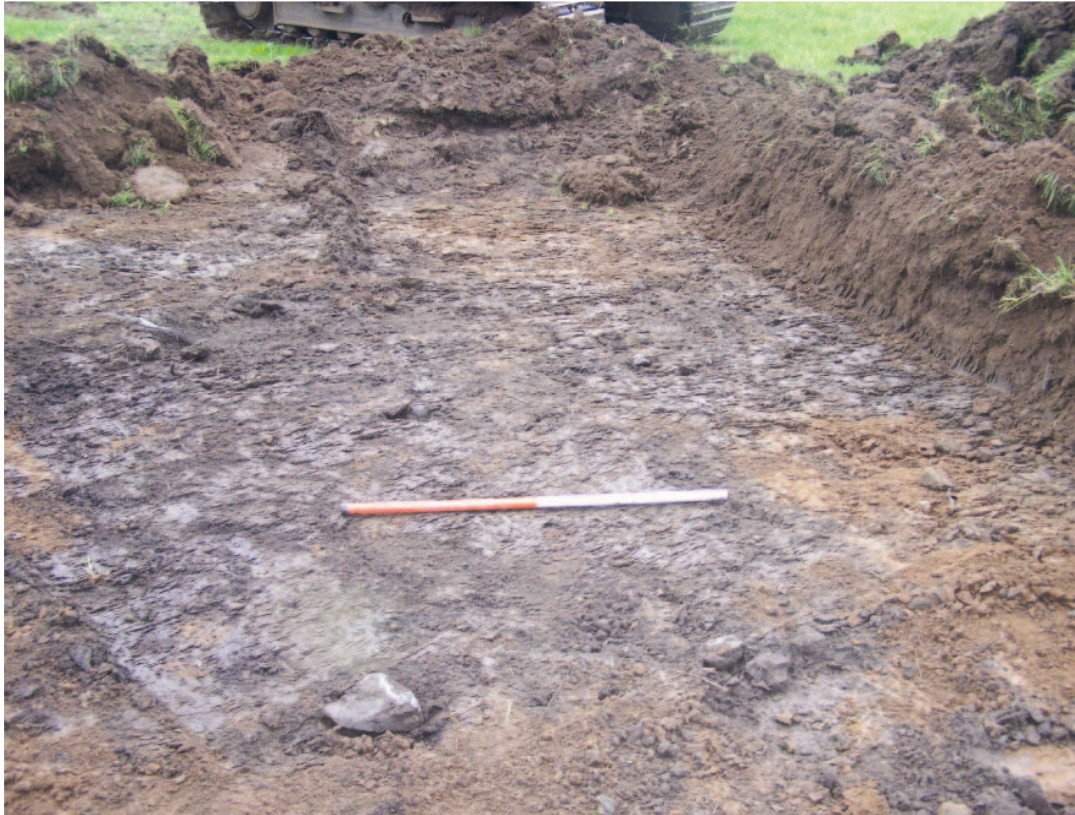
Plate 6: Excavation of Trench 1, looking NW, after the exposure of the grey ash layer (Context No. 108).

At the NW end of the trench a layer of ash with charred tree roots was encountered (Context No 108; Fig 7; Plates 6, 7), although the glacial cultivation soil did not show evidence of direct burning. A piece of late 19<sup>th</sup> 'Creamware' (Small Find No. 1) was recovered from this layer but did not show any evidence of heat fractures, which may suggest that the material had been disturbed. The ash layer continued towards the end of the trench, overlying a progressively deeper deposit of light brown/yellowish clay (Context No. 109). This clay deposit was relatively homogenous in composition, excepting some mottling of colour, reaching a maximum depth of 1.49 metres. No artefacts were recovered from this deposit. The clay deposit (Context No. 109) directly overlay the glacial subsoil (Context No. 103)

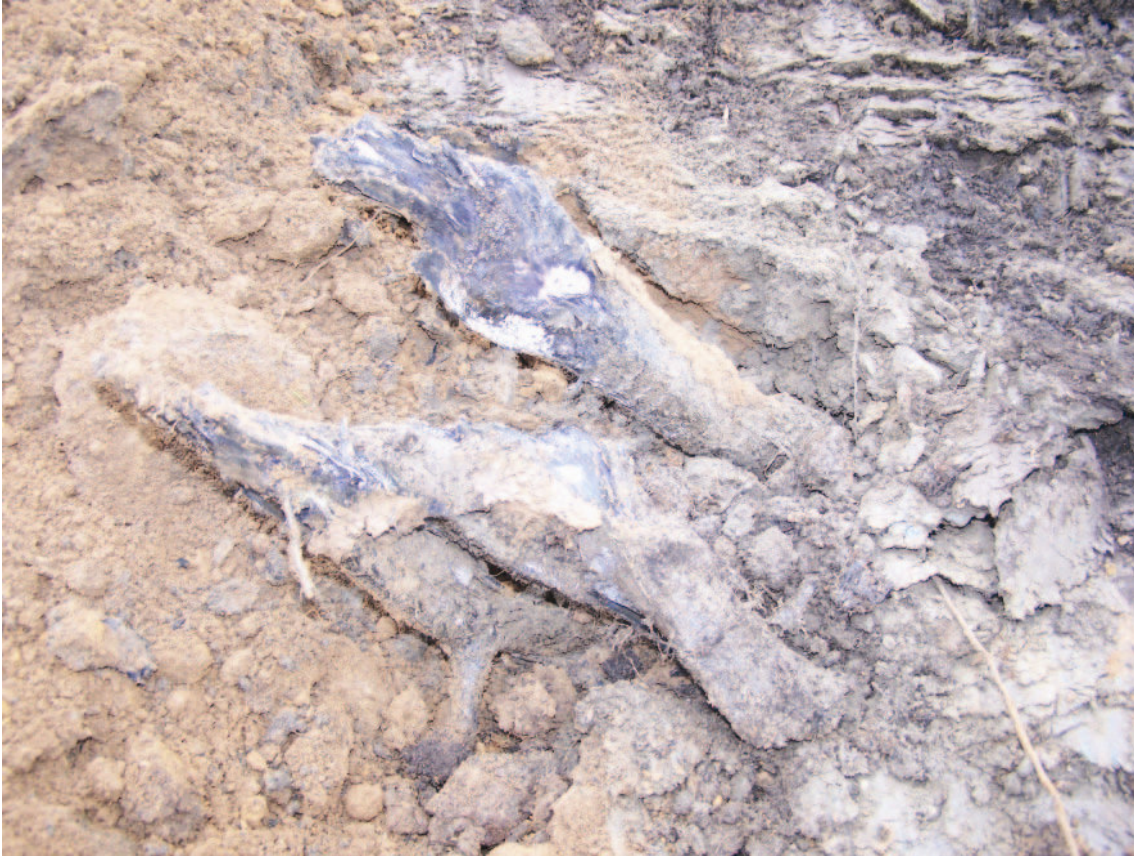
Plate 7: Close up of charred tree roots from the grey ash layer (Context No. 108).

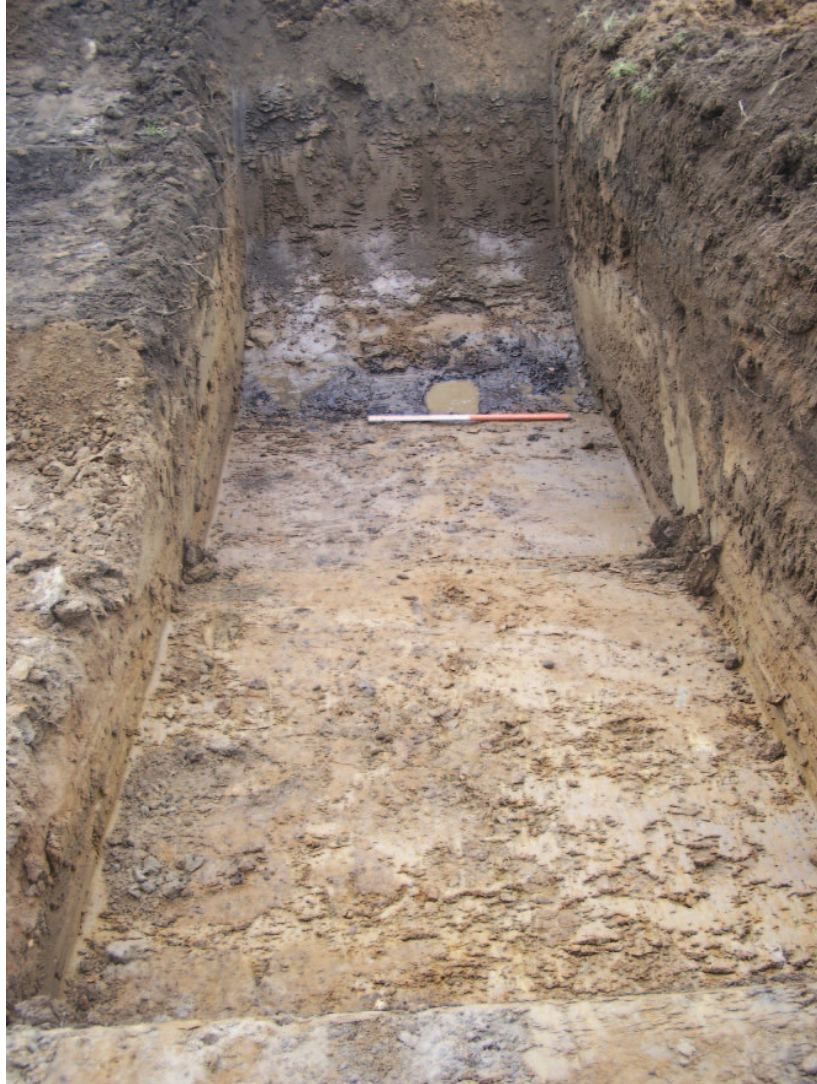
Plate 8: Trench 1 following the excavation of grey ash layer (Context No. 108) and clay layer (Context No. 109), revealing small peat filled drainage channel (Context No. 110). Looking NW.

At the base of the clay deposit a small rectilinear feature (Context No. 110; Fig. 8; Plate 8, 9, 10), filled with waterlogged peat (Context No. 111), was encountered which had a regular steep sided profile, and a maximum depth of 6 cm. No finds were recovered from this feature.

On removal of the clay layer (Context No. 109) a small rectilinear feature (Context No. 110), filled with a waterlogged peat (Context No. 111), was uncovered. This feature probably represents the remains of a drainage channel, however, the depth of the feature may suggest that it was vertically truncated before the clay layer was laid down. The peat at the bottom of this feature would seem to indicate that it had been left open for some time, although establishing the time scale necessary for such growth is problematic, compounded by the fact that no datable evidence was recovered from the feature.

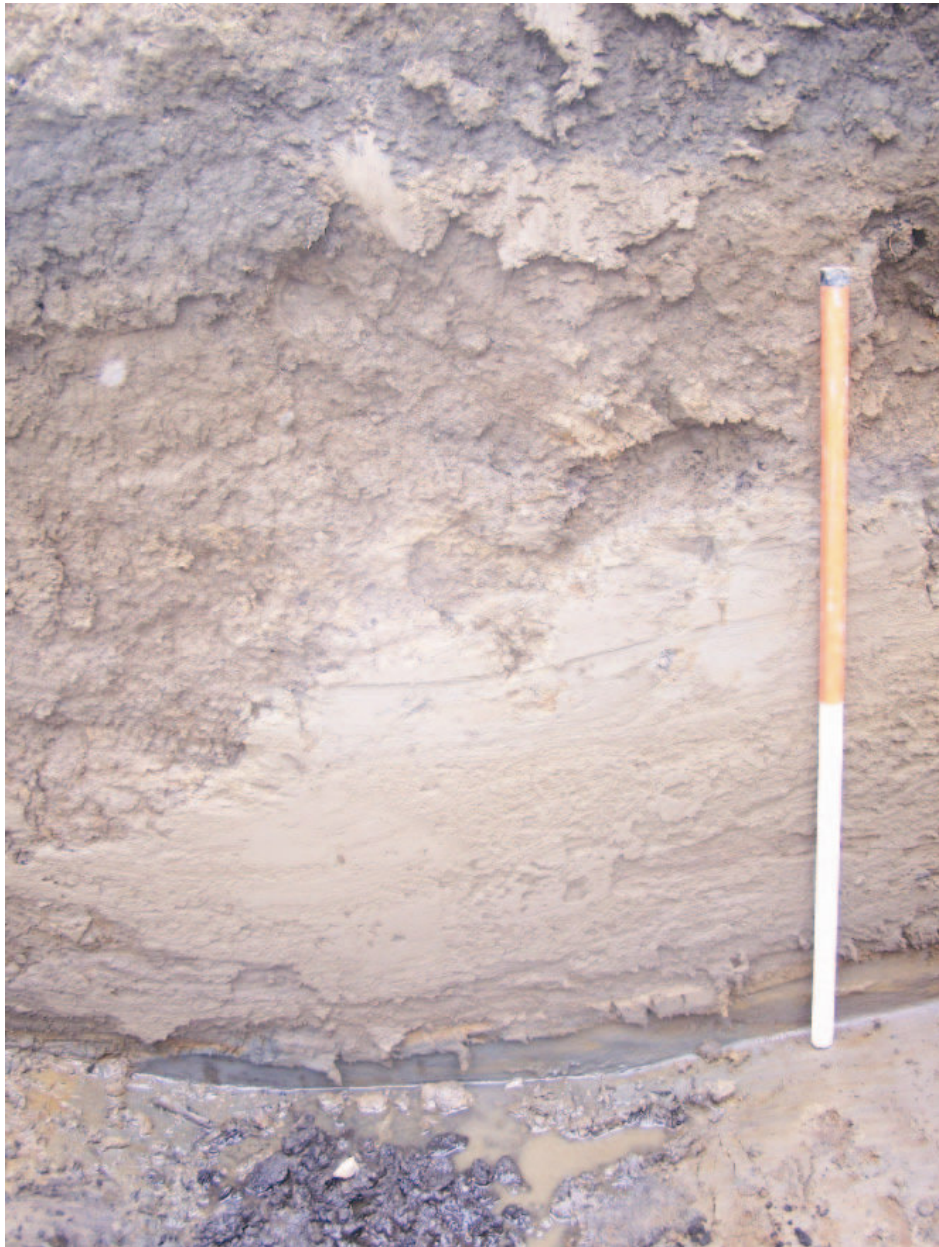
Plate 9: Trench 1 following the excavation of clay layer (Context No. 109) above the small peat filled drainage channel. Looking NE.

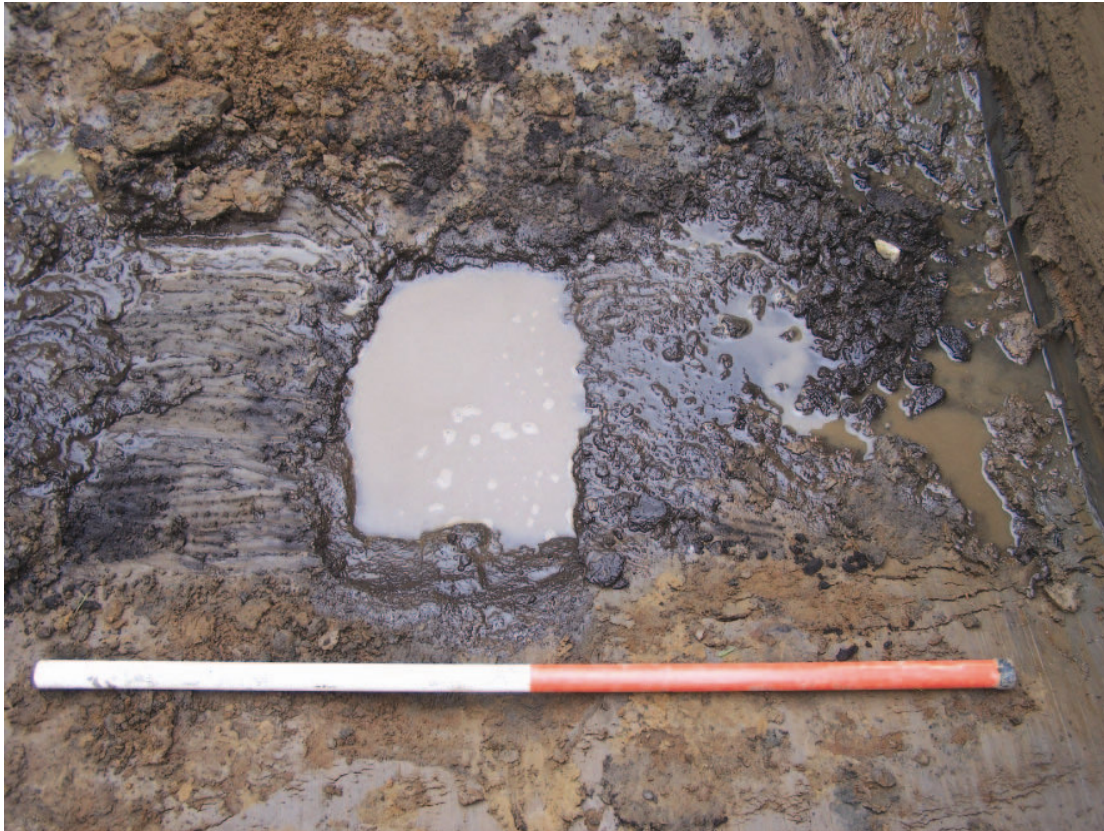
Plate 10: The small peat filled drainage channel following half sectioning and removal of peat, illustrating the high water table.

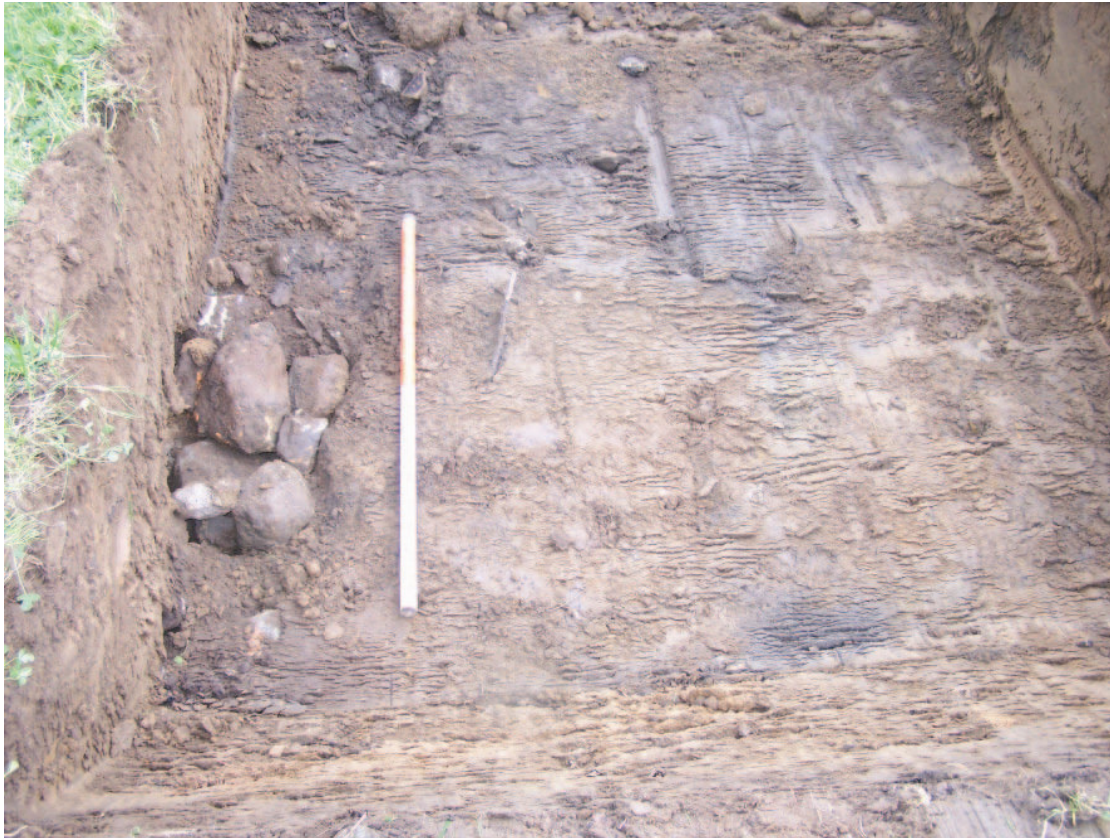
Plate 11: Trench 2, looking SW following the removal of the topsoil (Context No 201) and cultivation soil (Context No. 202), revealing the field drain feature.

Trench 2 was excavated to investigate the curve of the proposed driveway on the development site (see Fig. 4). The trench was approximately 2 metres wide by 5 metres in length. The topsoil (Context No. 201) was a dark brown sandy clay with organic inclusions with a maximum depth of c. 10 cm, analogous with the topsoil layer of Trench 1. The topsoil overlay a light brown sandy clay cultivation soil (Context No. 202) approximately 60 cm deep. This cultivation soil layer lay over a light brown/yellowish clay layer (Context No. 203) which had a field drain feature (Context No. 204; Fig 5; Plate 11, 12) cut into it, containing large stones (Context No. 205) with

In Trench 2 the field drain feature (Context No. 204) cut into the clay layer (Context No. 203) may be part of drainage associated with the area flanked by the two lines of trees shown in the 1858 OS revision map. However, the depth of cultivation soil (Context No. 202) would suggest that it had been artificially raised. Therefore it is possible to suggest that the field drain is associated with an earlier drainage of the land to the NW of the motte, possibly from the 17<sup>th</sup> century onwards given the drain construction. It may well be suggested that the present land surface was created by the introduction of the cultivation soil, and then flanked by the lines of trees shown in the 1858 OS map revision, probably late 17<sup>th</sup>/early 18<sup>th</sup> century at the earliest.

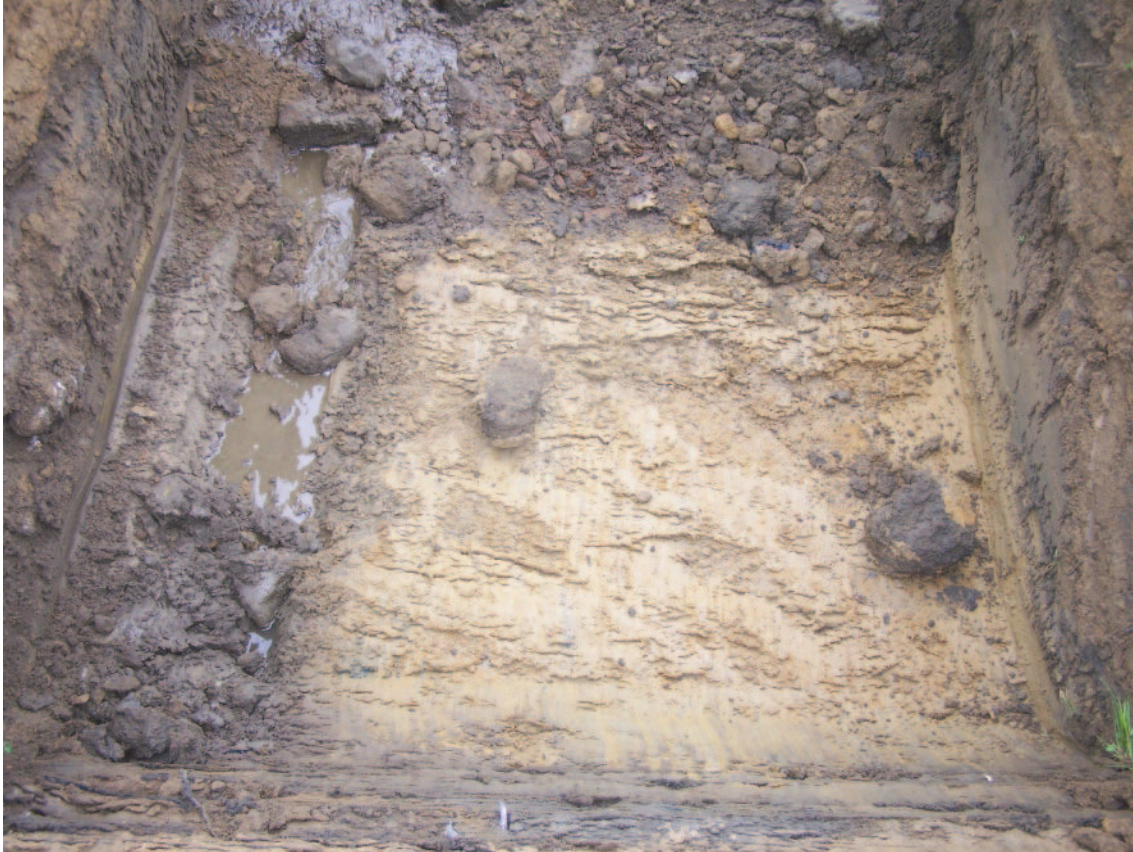
Plate 12 Trench 2 looking SW following the removal of the field drain, showing the yellowish brown clay layer (Context No. 203). The excavation was halted after a pressurized water pipe was ruptured.

noticeable voids. A piece of late 19<sup>th</sup> century 'Blackware' (Small Finds No. 2) was recovered from the cultivation soil layer (Context No. 202). The excavation of this trench was halted when a pressurized water pipe was ruptured.

That the field drain (Context No. 204) is cut into the clay layer (Context No. 203) in Trench 2 would suggest that the clay layer had been deposited prior to early modern landscaping. If the clay layer in Trench 2 is of a comparable depth to that encountered at the SW end of Trench 1, then a significant amount of material may have been artificially deposited in this area.

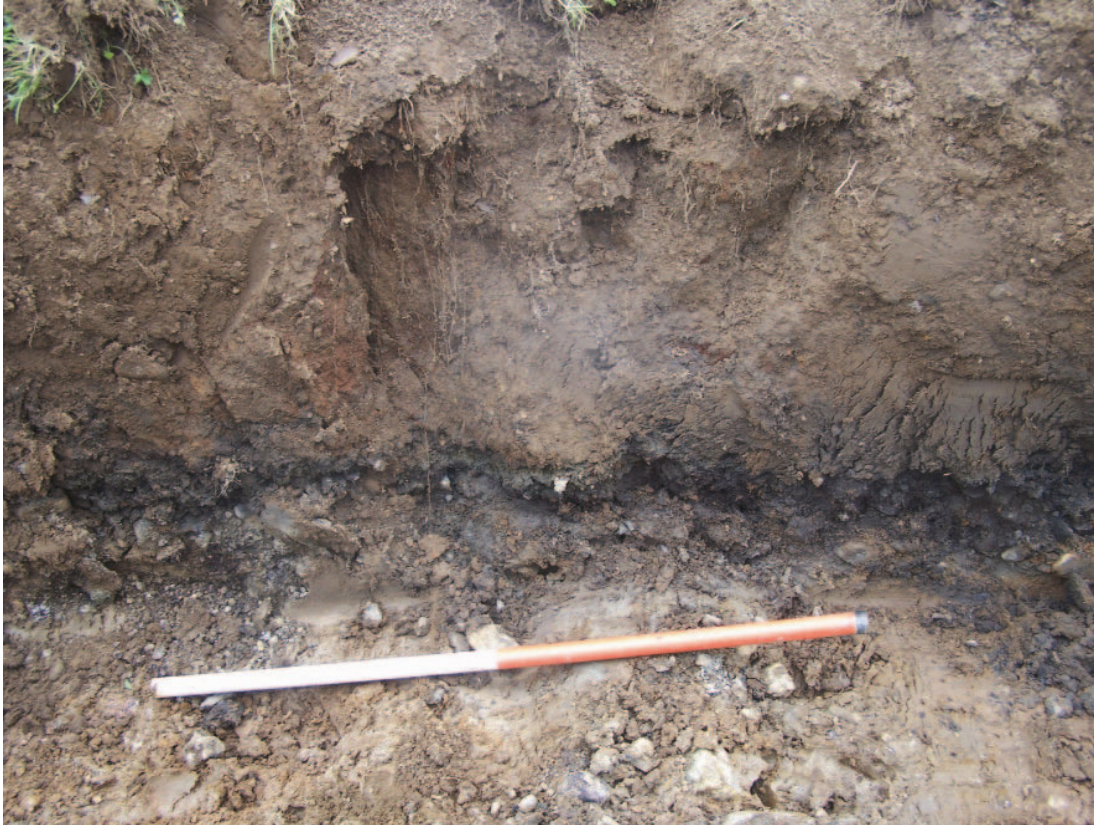
Plate 13: Trench 3 looking NW following the removal of topsoil (Context No. 301), cultivation soil (Context No. 302) and late 19<sup>th</sup> century building debris (Context No. 303).

Trench 3 was excavated at the terminus of the proposed driveway. The trench was approximately 2 metres wide x 10 metres in length. The topsoil layer (Context No. 301) was a mid brown sandy clay with organic inclusions, maximum depth of c. 10cm, which overlay a light brown sandy clay cultivation soil (Context No. 302), c. 40 cm in depth, largely differentiated from the topsoil because of the difference in consistency, the topsoil being more friable. The cultivation soil layer overlay a layer of building debris (Context No. 303; Plate 13) evenly distributed throughout the trench with a depth ranging from 11cm to 22cm. This layer of building debris directly overlay the glacial subsoil which consisted of a stony orange brown sandy clay (Context No. 304). A large piece of late 19<sup>th</sup> century 'Blackware' (Small Finds No. 3) was recovered from the layer of building debris, no other finds were recorded.

In Trench 3 the layer of building debris is of definite late 19<sup>th</sup> century date, and on its removal did not conceal any features of potential archaeological significance. However, the level of the glacial subsoil (Context No. 303) would seem to indicate that the clay filled hollow noted to the NW of the motte does not extend as far as Trench 3.
